# Vehicle contained HF radio

Lachlan Macallan

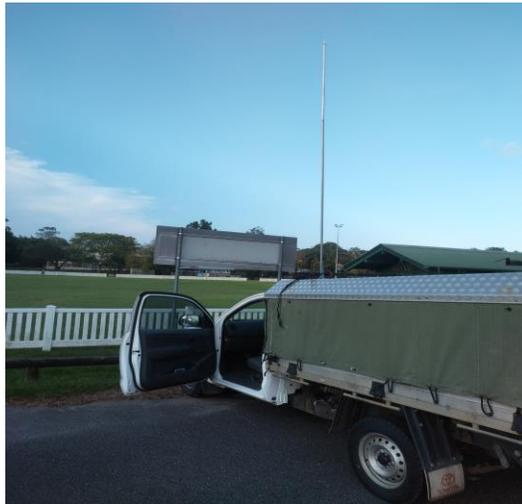
Insulating rubber was placed between the antenna and the conductive canopy, nylon bolts were used to fix it to the canopy to maintain electrical separation. The antenna consisted of a hinge attached to a folding metal pipe approximately 2.5m long. A cam strap securely fitted to the canopy was used to secure the antenna when stowed, when extended and lifted the antenna was held against the insulated ladder rack by a spare cam strap for operation, the spare cam strap is used to hold the antenna together when stowed.

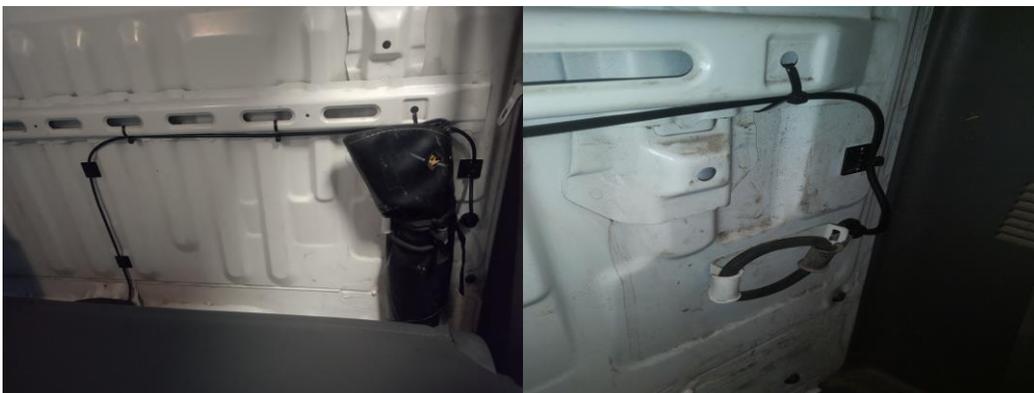
The coaxial cable was installed in a protected manner underneath the interior vinyl, exiting the cabin through an IP rated gland.

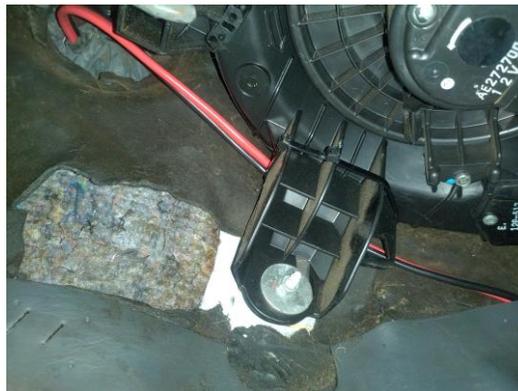
The power cable was joined to a pre-terminated anderson power pole plug via a soldered connection, this connection had individual and overall heatshrink wrapping. The cable was installed securely behind the dash and routed through the firewall via the approved manufacturers' cable way.
